Evaluation of the Effectiveness of Environmental Dredging at Contaminated Sediment Sites

EPA Forum on Managing Contaminated
Sediments at Hazardous Waste Sites

May 31, 2001

J. Paul Doody, P.E.
Blasland, Bouck & Lee, Inc.

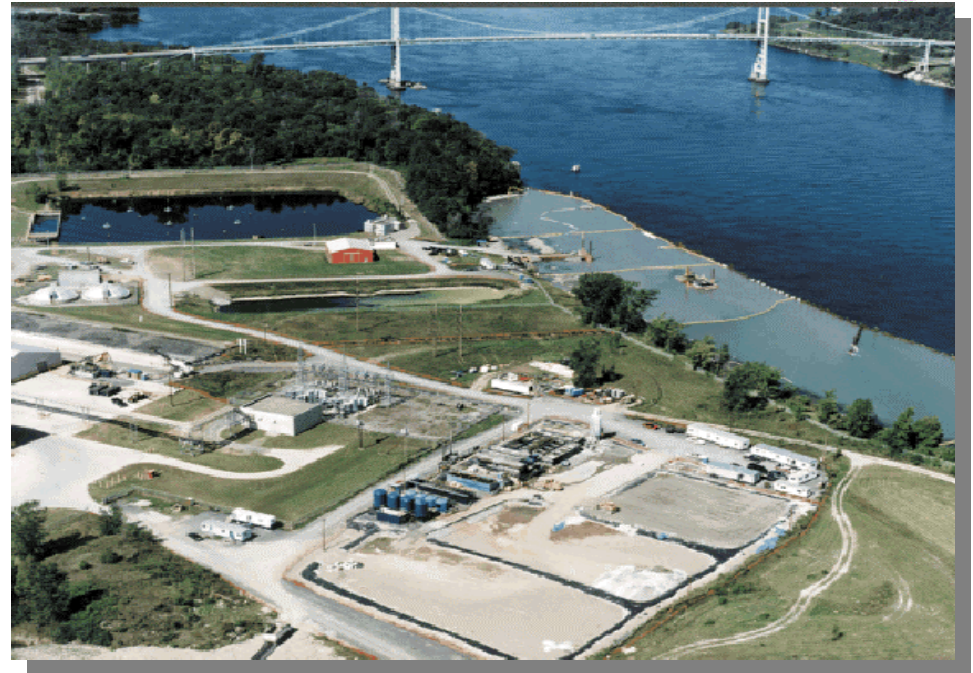
St. Lawrence River - GM Massena: Hydraulic Dredging

- 11-acre area of nearshore sediments dredged in 1995
- Goal → 1 ppm PCB (sediment)
- Mechanical debris removal and hydraulic dredging (horizontal auger)
- 1 ppm cleanup goal unachievable (up to 30 passes)
- Average surficial PCBs → 9.2 ppm
- One area capped after removal

1 ppm PCB cleanup goal for sediment was unachievable, even with significant effort.

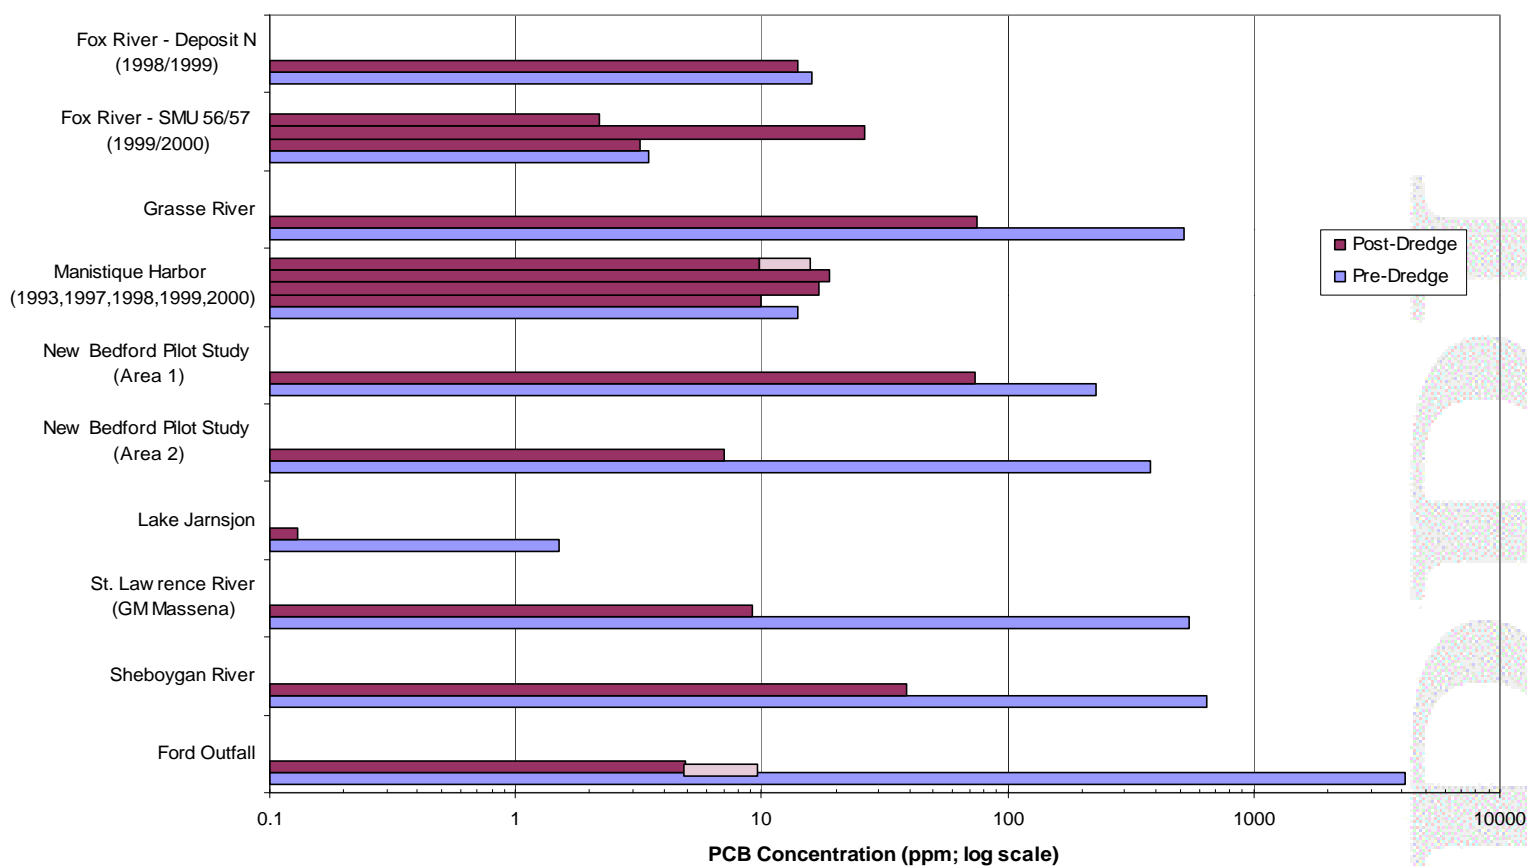
Average Surface Sediment PCB Data at Select Dredging Sites

Reduction to typical guidance levels (i.e., < 1 ppm) not consistently demonstrated.

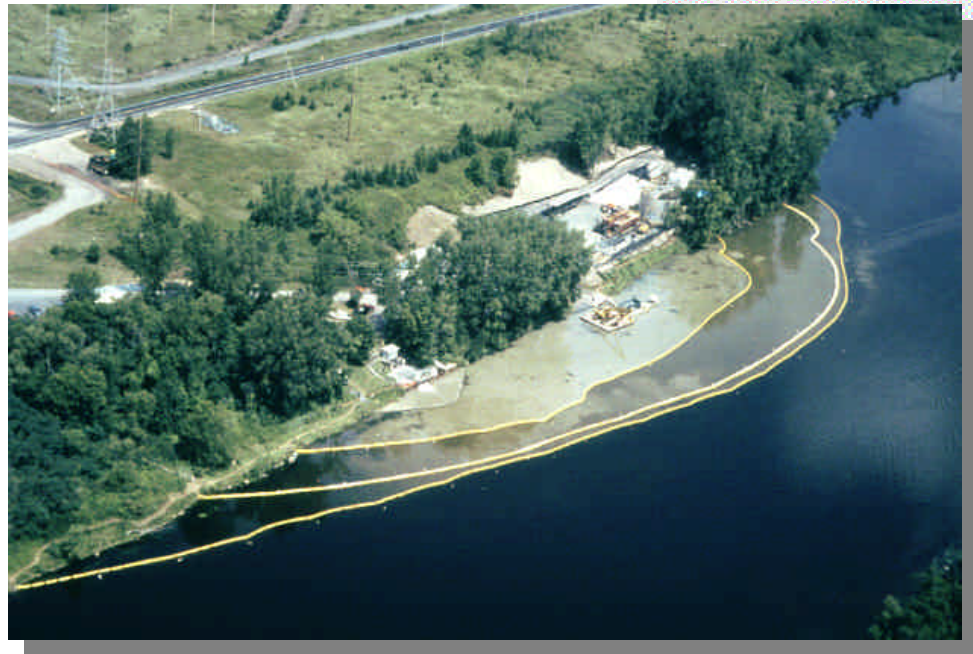
Grasse River - Massena, NY

- 3,000 cy sediment and debris with PCBs removed in 1995 Mechanical debris removal and hydraulic dredging (horizontal auger)
- Sediment dewatered and disposed on site
- Goal: Removal of “all” sediment
- Heavily studied/monitored program
- Silt containment retained TSS
- Elevated PCBs observed downstream during operations (water & caged fish)

PCB releases were observed during dredging and were bioavailable.

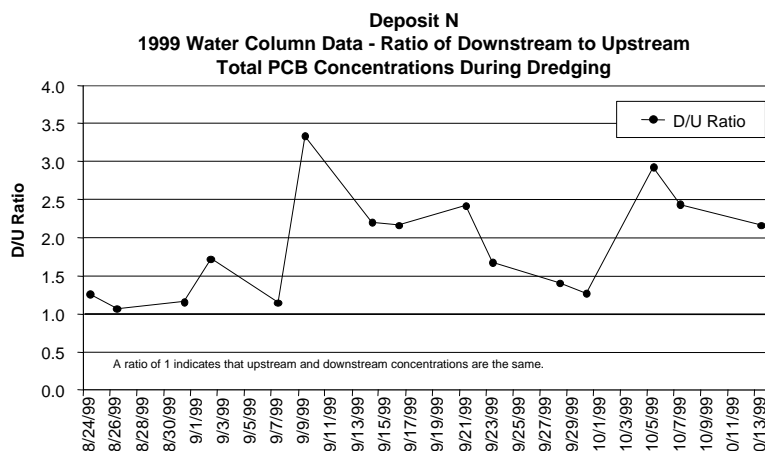
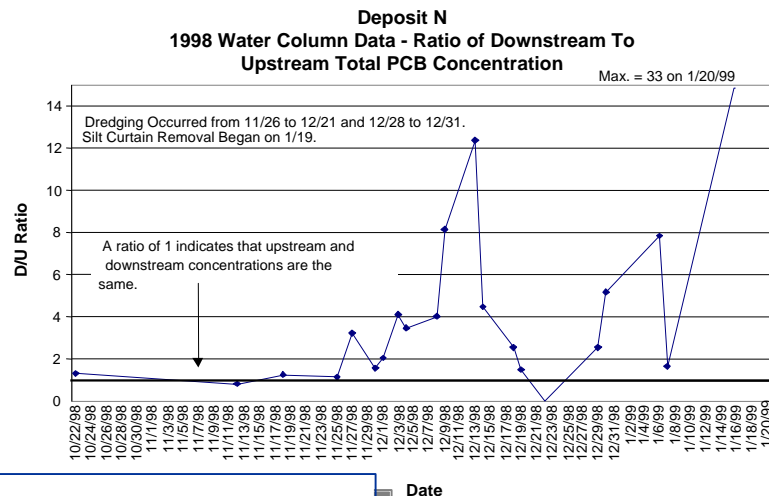
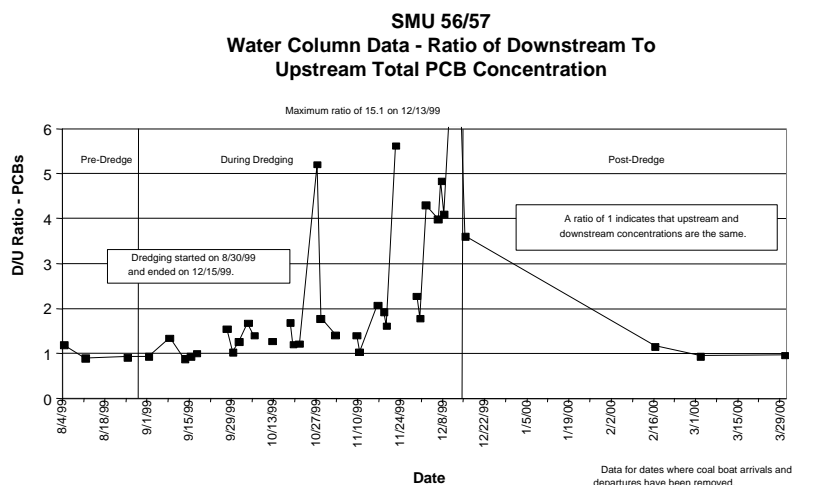
Fox River

Evidence that PCBs were released from the dredging operation.

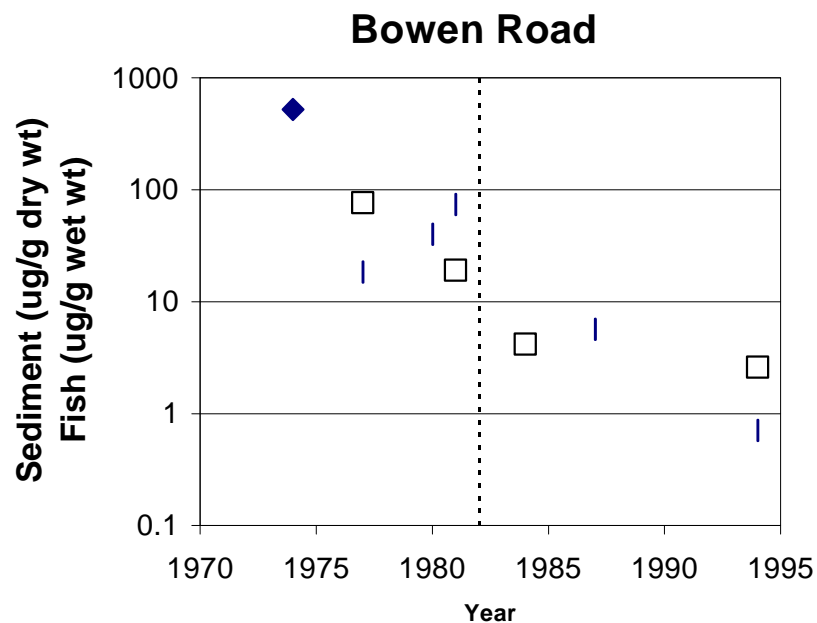
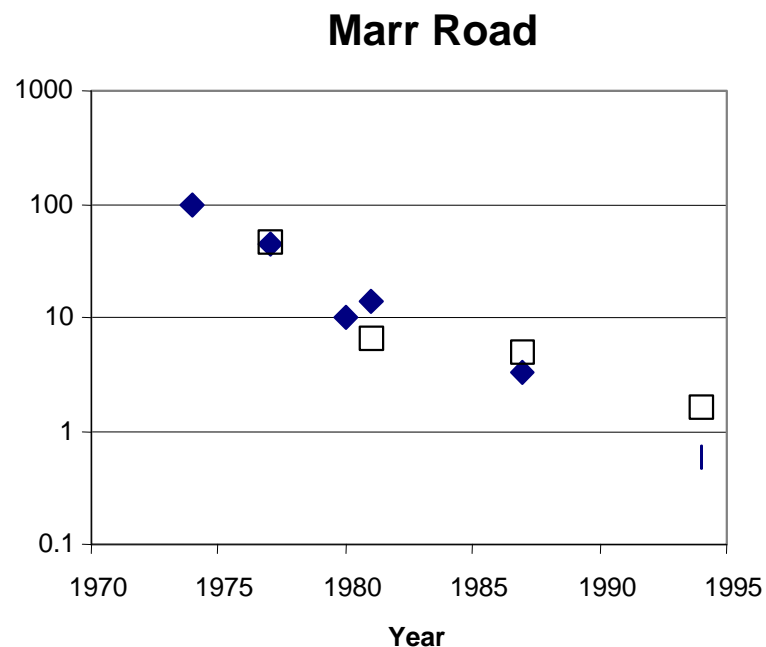
◆ Sediment □ White Sucker fillet Remediation

**Total PCB concentrations in white sucker and sediments
from the Shiawassee River**

**A simple comparison of before and after ignores the
observation that natural recovery was ongoing and continuing.**
